ASSET MANAGEMENT OF A HEAVY HAUL RAILWAY IN NORTH AMERICA

—
Stephen Ashmore – Union Pacific Railroad

5/8/2023

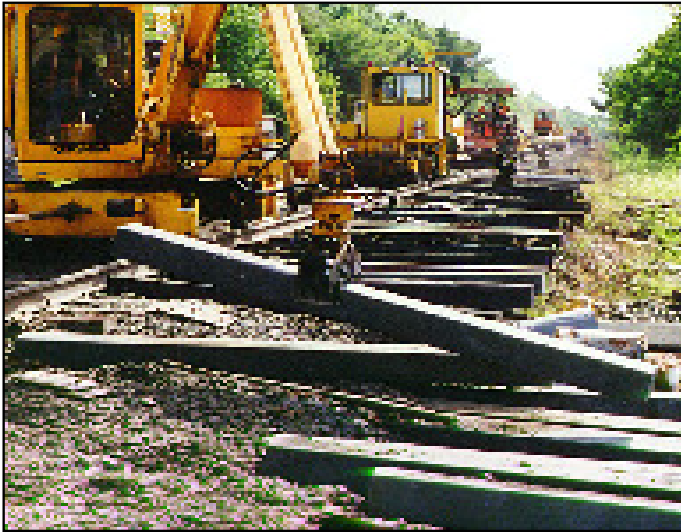
Wood Ties

> 87 Million (27k
Miles)

> 89% of Network

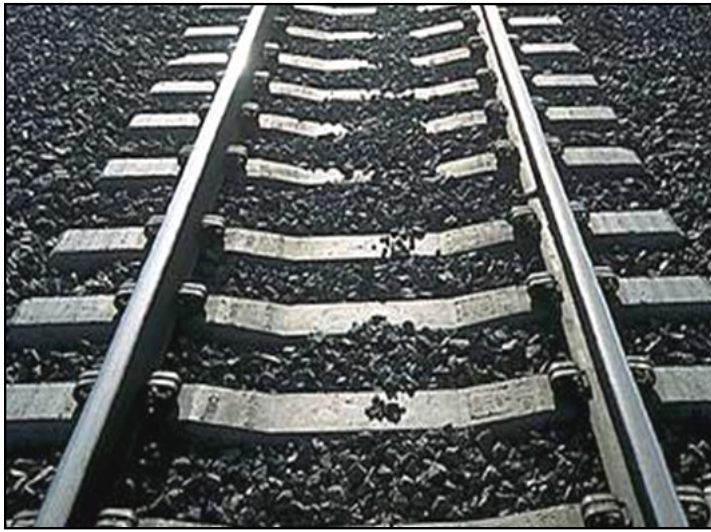
Concrete

~ 10.2 Million (3900
Miles)

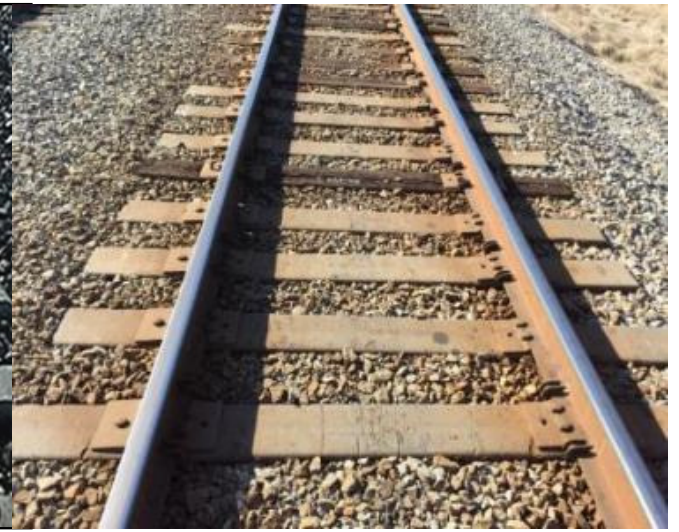
Composite

< 1 Million

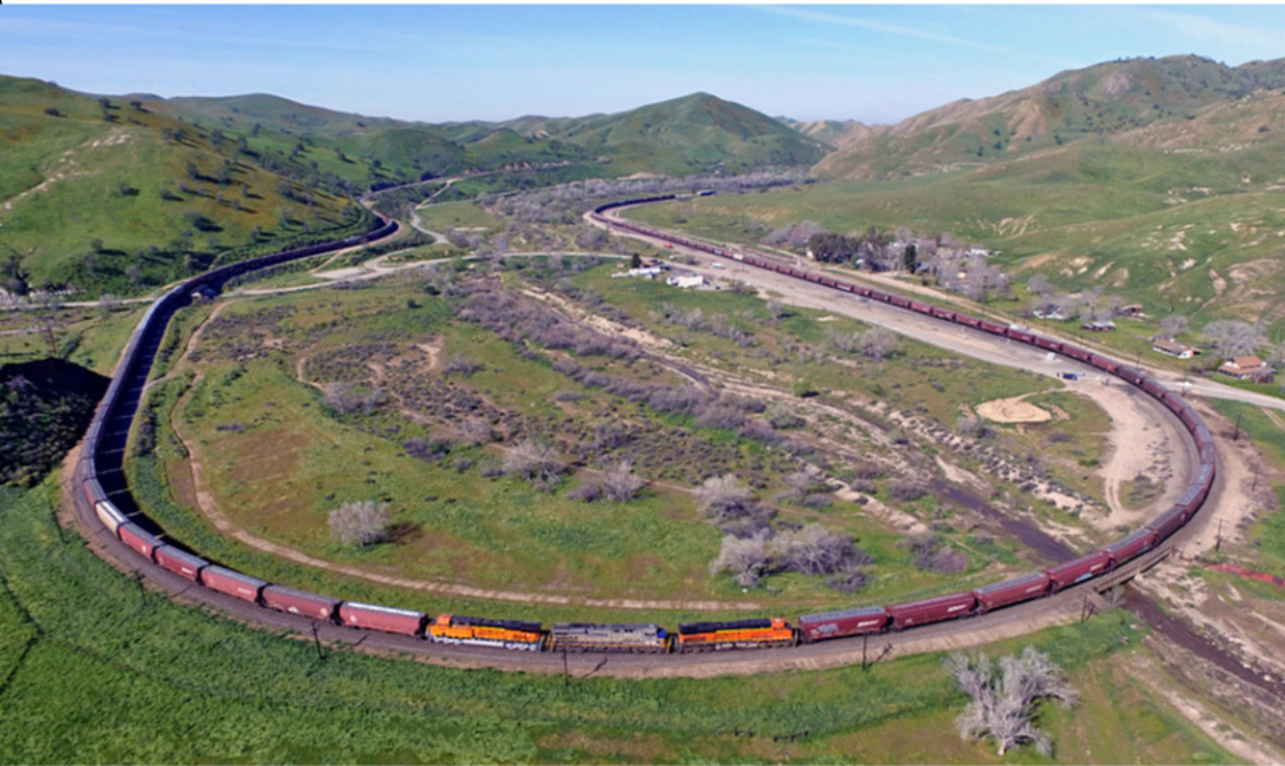
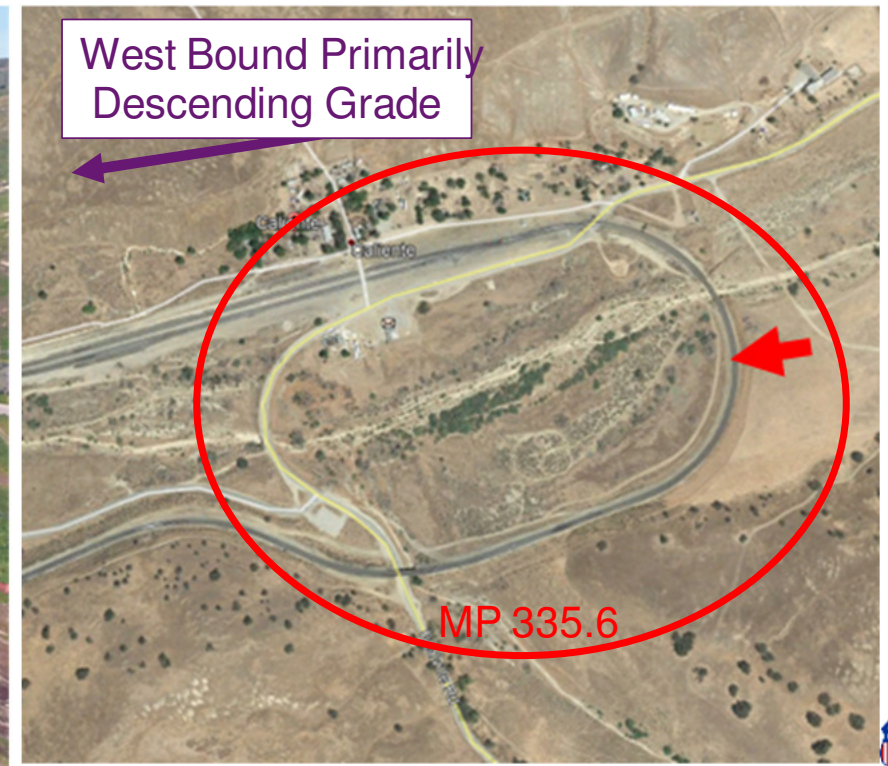
Horseshoe Curve – Monitoring Stations

- Very large variance in L/V depending on train length, operating speed, train handling and train makeup
- Not uncommon to see L/V in excess of 0.4
- Very common to see trains operating well below maximum authorized speed
 - Curve Speed 31 MPH
 - Avg. Speed 19.2 MPH

Horseshoe Curve – Caliente California

- One of the most severe operating environments on the Union Pacific
- 10 Degree curve, 31 MPH operating speed

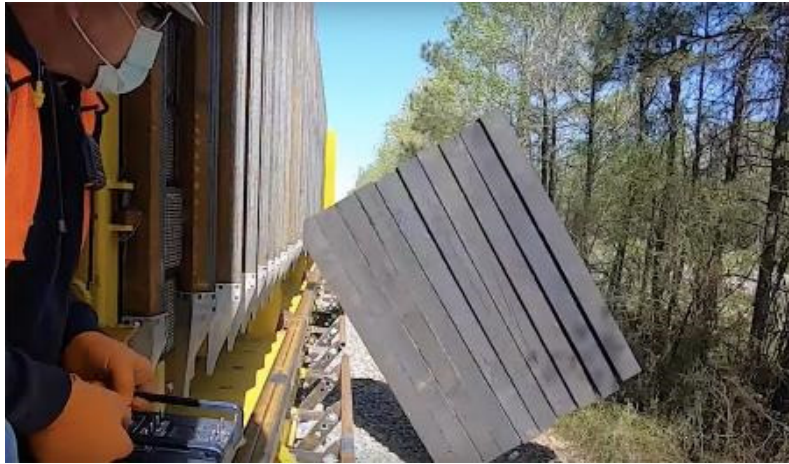
The Future of Automation – Tie Unloading

Operating and Capacities:

- 60 car train
- 560 ties per car
- 33,600 ties per unit train
- ~3 min per car / 3 hrs per train
- Cuts time required to unload ties by 95%

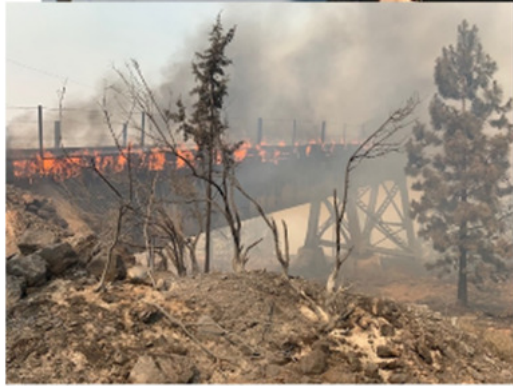
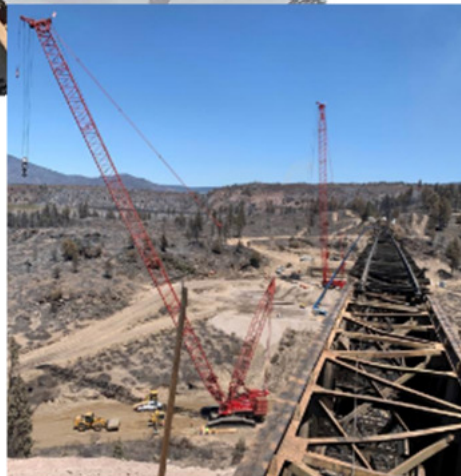
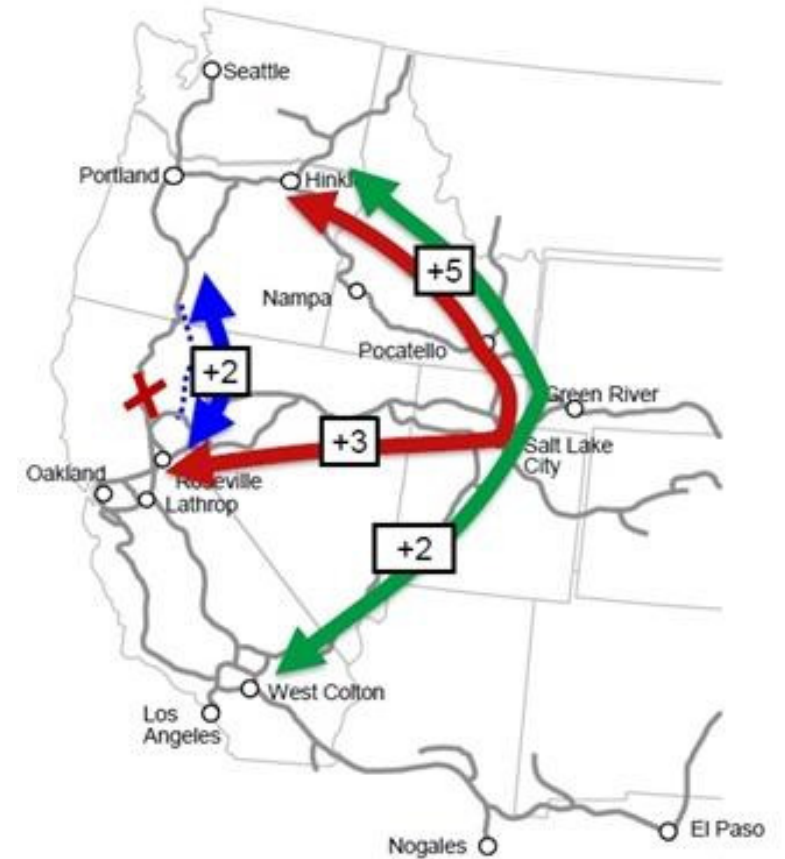
The Lava Fire damaged the Union Pacific's Dry Canyon Bridge located near Hotlum, California.

Lava Fire (Black Butte Sub) 6/28/2021 – 8/1/2021

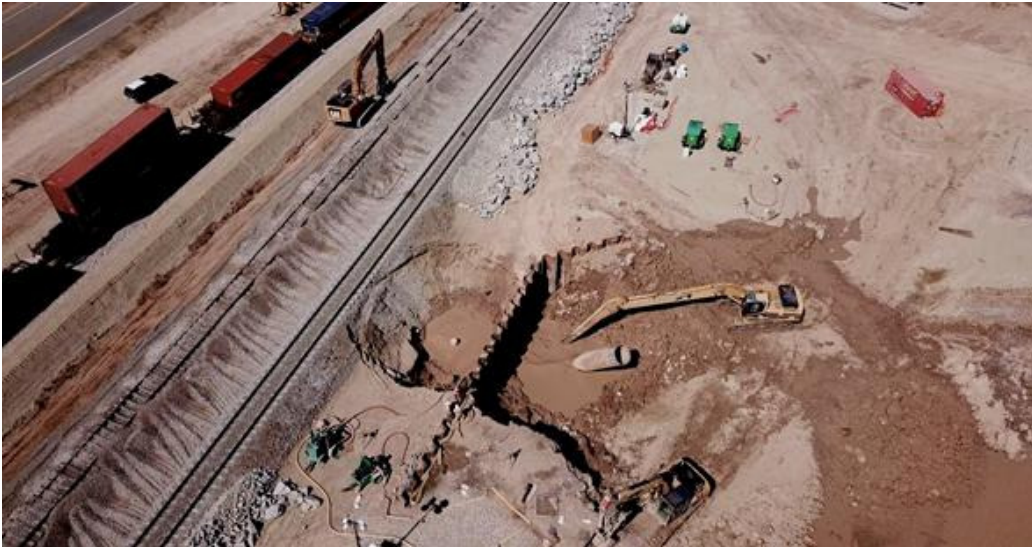
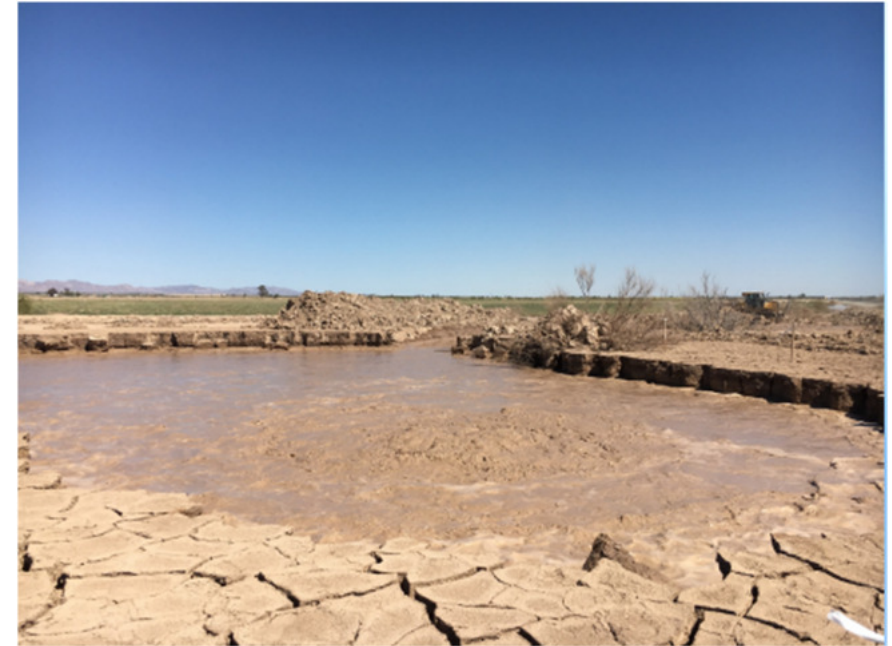
Wister, CA – The Bubbling Mud Pot

- Caused by water or sulfurous gas being pushed up through soil and sediment
- Active since the 1950s, but aggressively began moving toward our tracks in 2018
- Efforts to install sheet pile to slow the movement of the mud pot were only mildly successful
- In 2018, constructed Shoofly tracks around the mud pot to continue to run business at a slightly reduced speed
- Currently impacting California highway 111, approx. 4 – 6 months away from being clear of tracks at which time UPRR will correct alignment

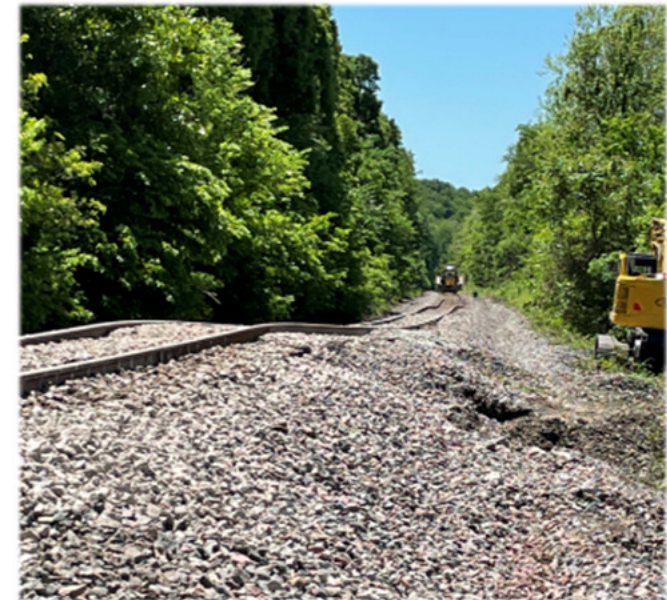
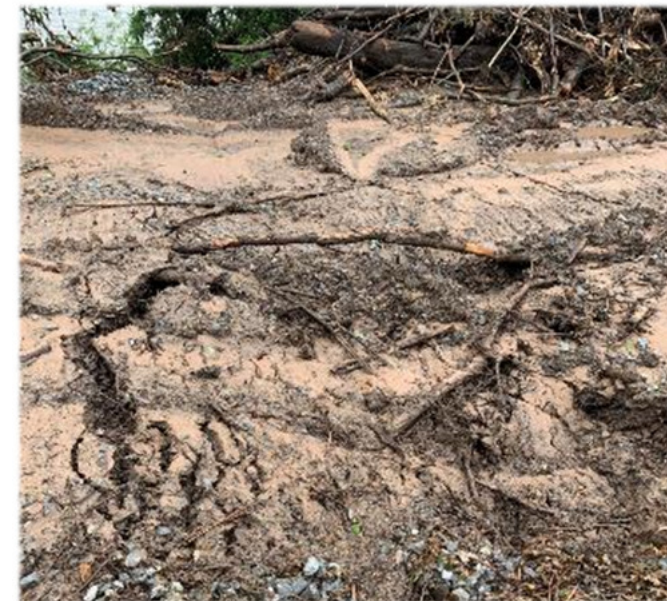
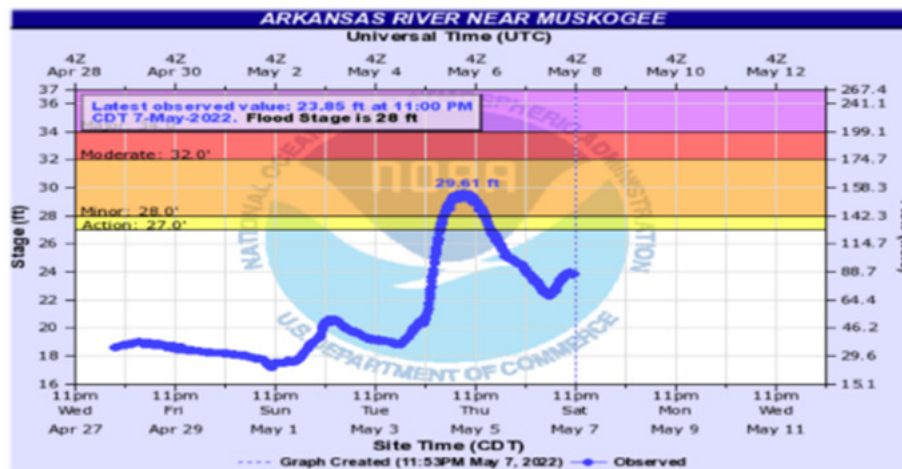
Wagoner Sub MP563 Slope Failure

- Greater than 8 inches of rain in 24-hour period in early May 2022
- Over 5 inches of rain fell in a 3-hour period – Greater than 500-year flood event
- Massive waterflow spike in Arkansas river coinciding with the slope failure event – large amount of runoff toward the river
- Estimated repair cost \$2-5M initial stabilization repairs, \$3M long term repair (US Dollars)
- Repair completed as in December 2022
- Failure section was ~1100 feet long and over 150 feet high – Loose rock layer with clay soils

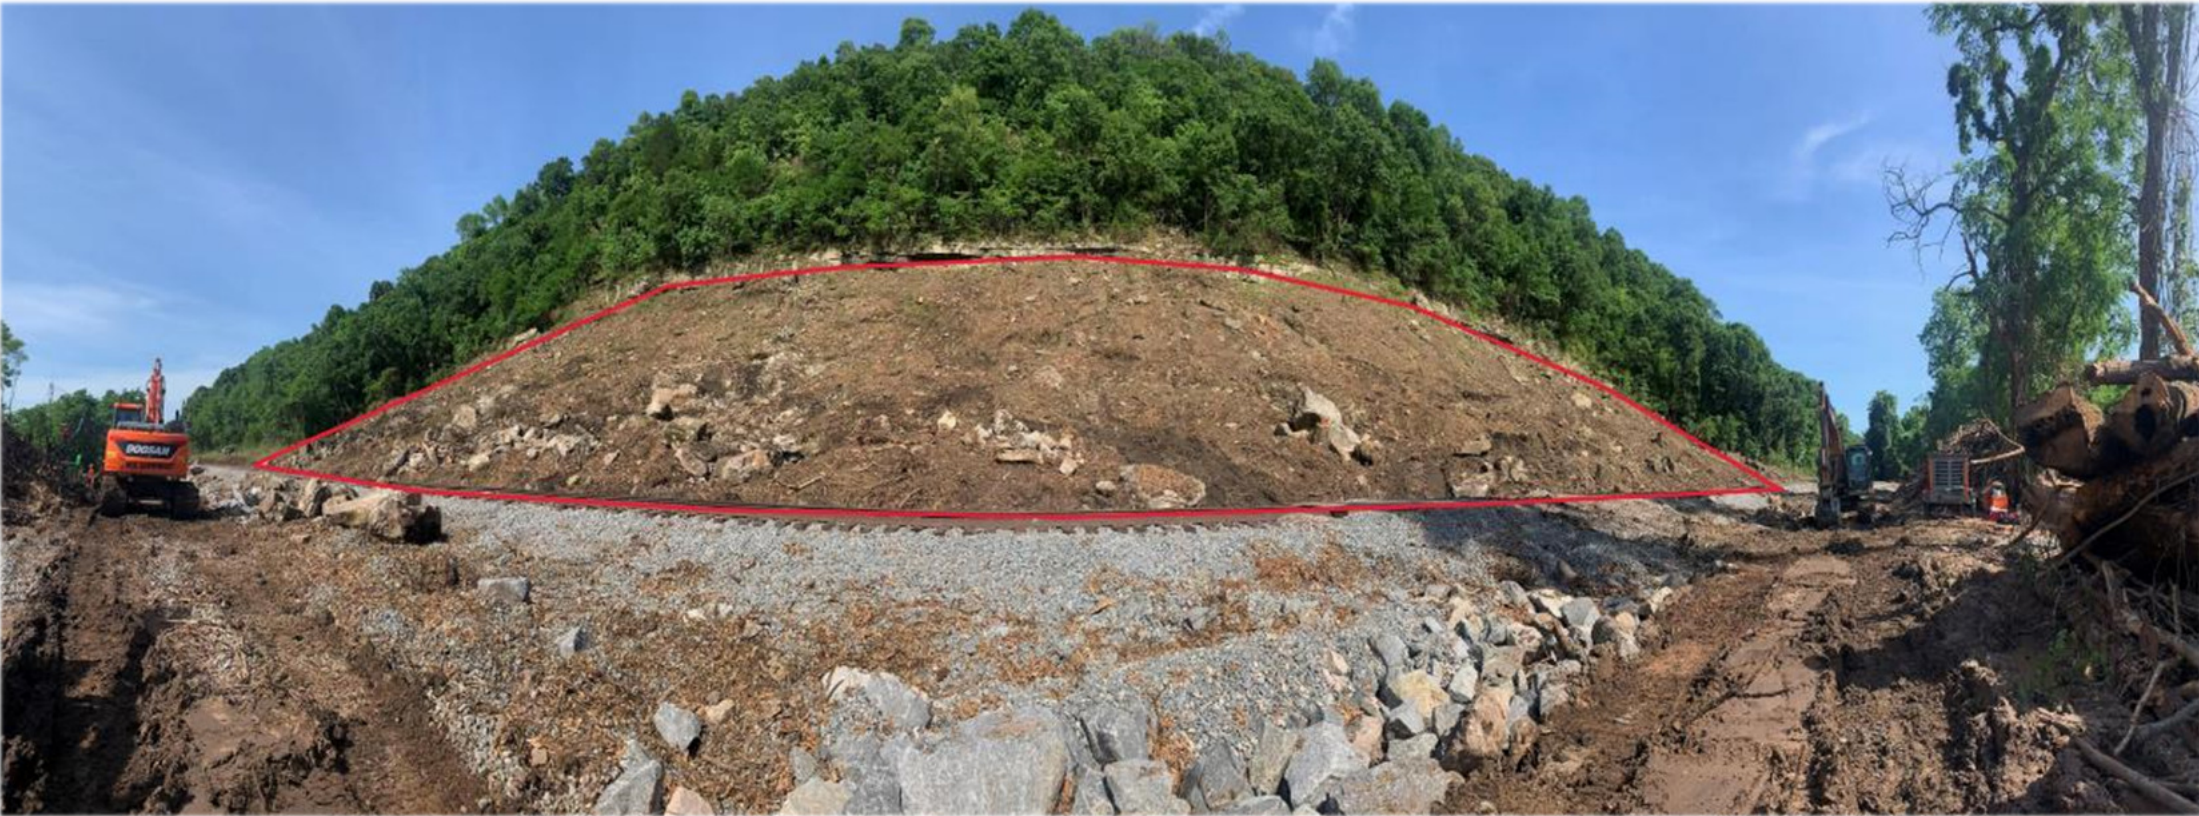
Slope following initial clearing and repair work - June

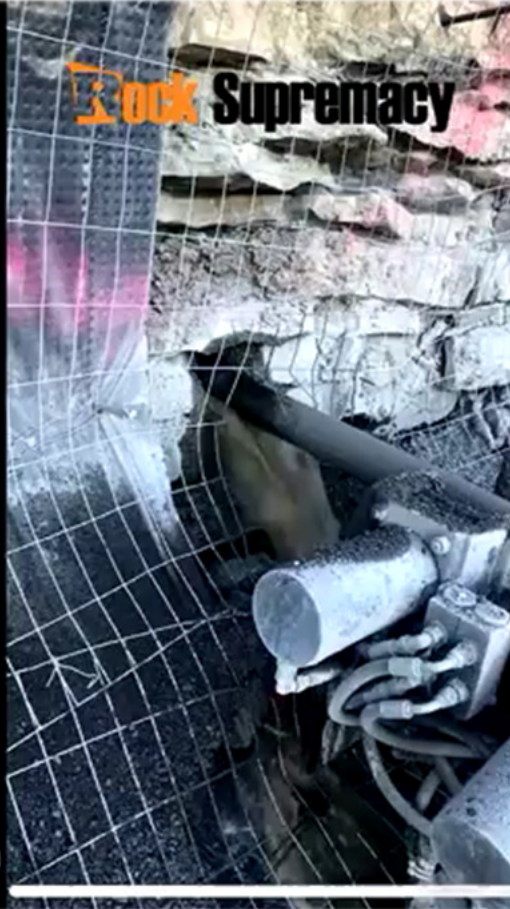
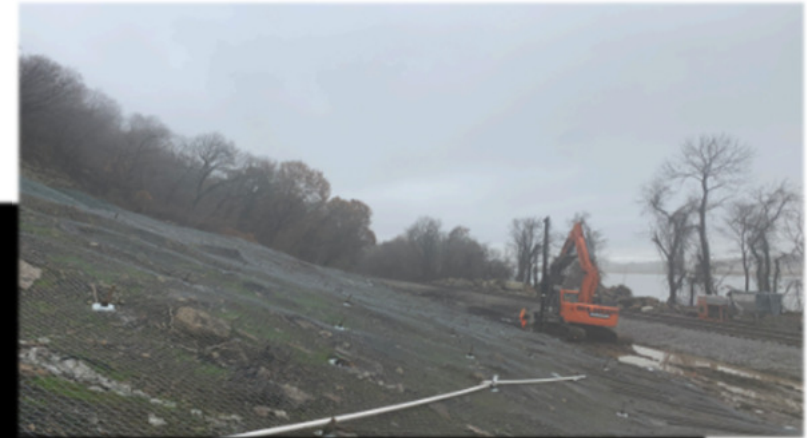
**Horizontal Drain
Wagoner Slope Stabilization
10/18/2022**

Draining the Slope - August

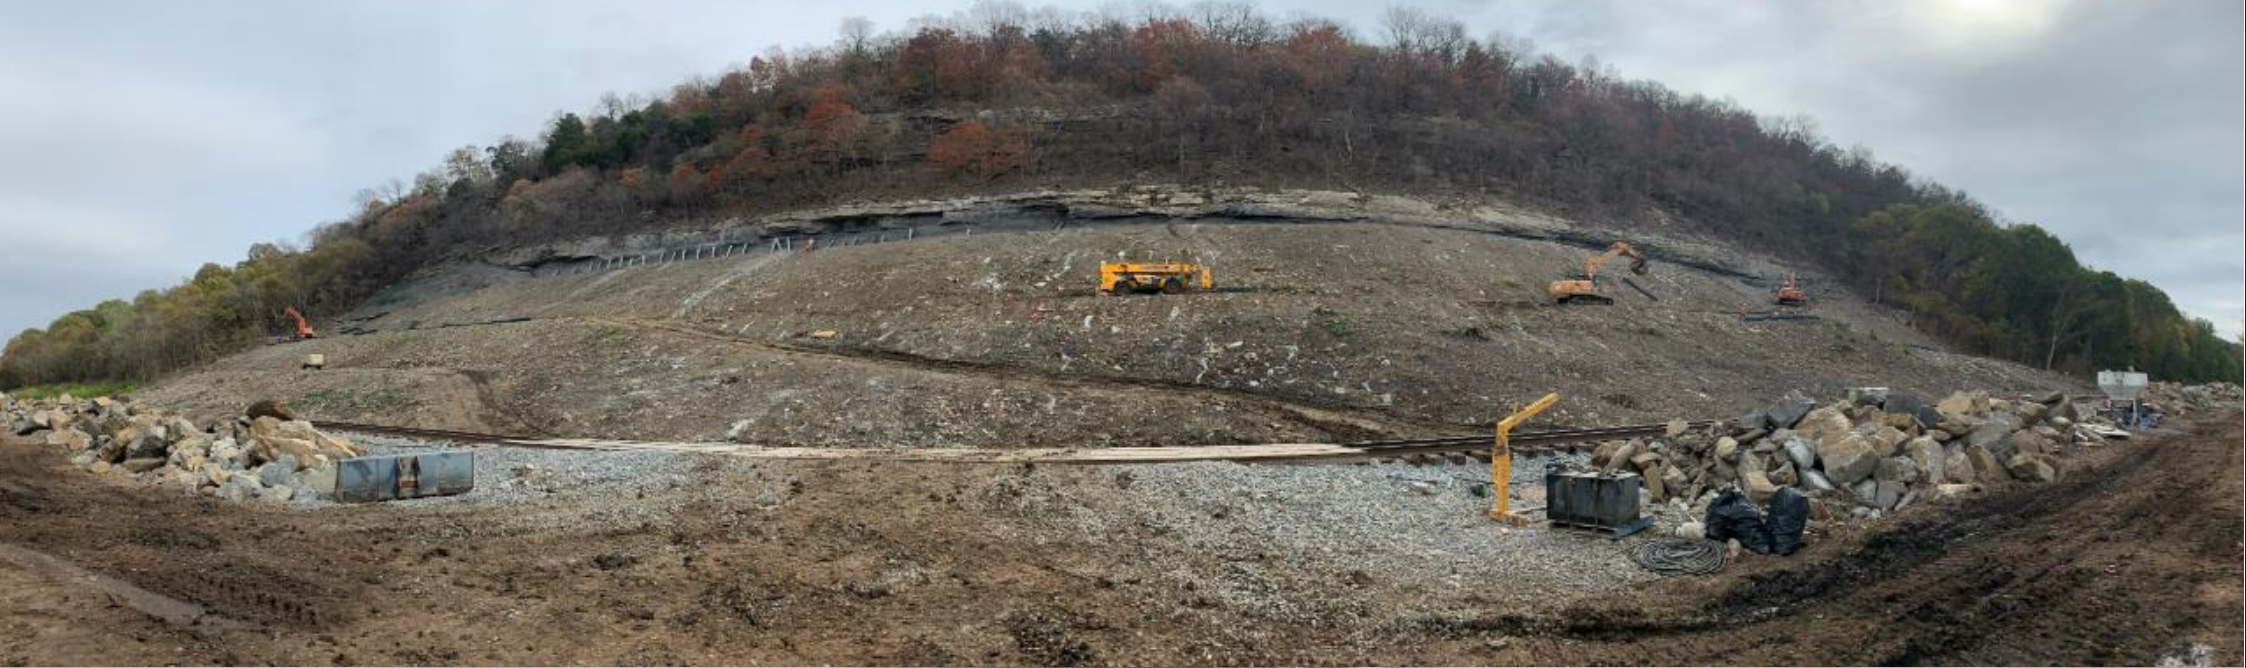
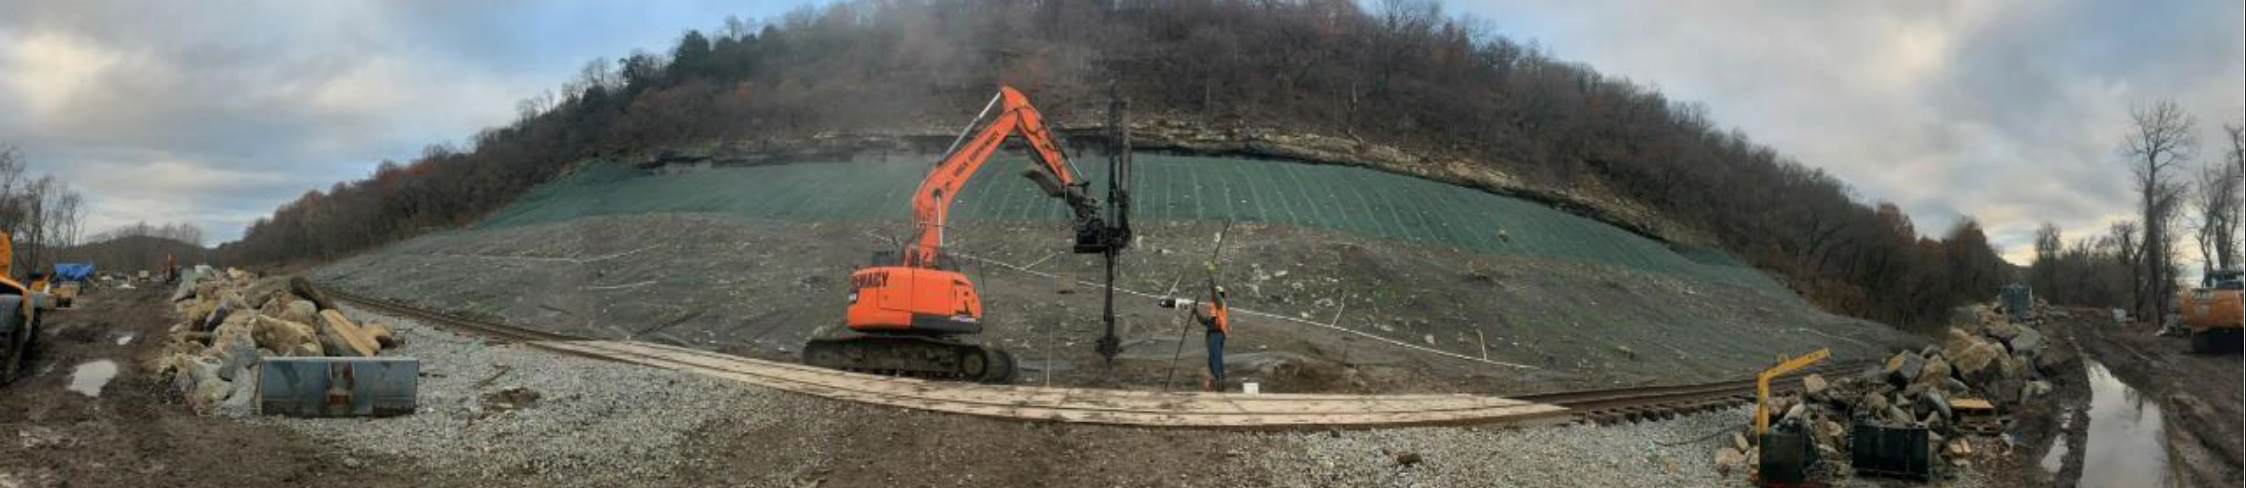
Installing Additional Drainage – September

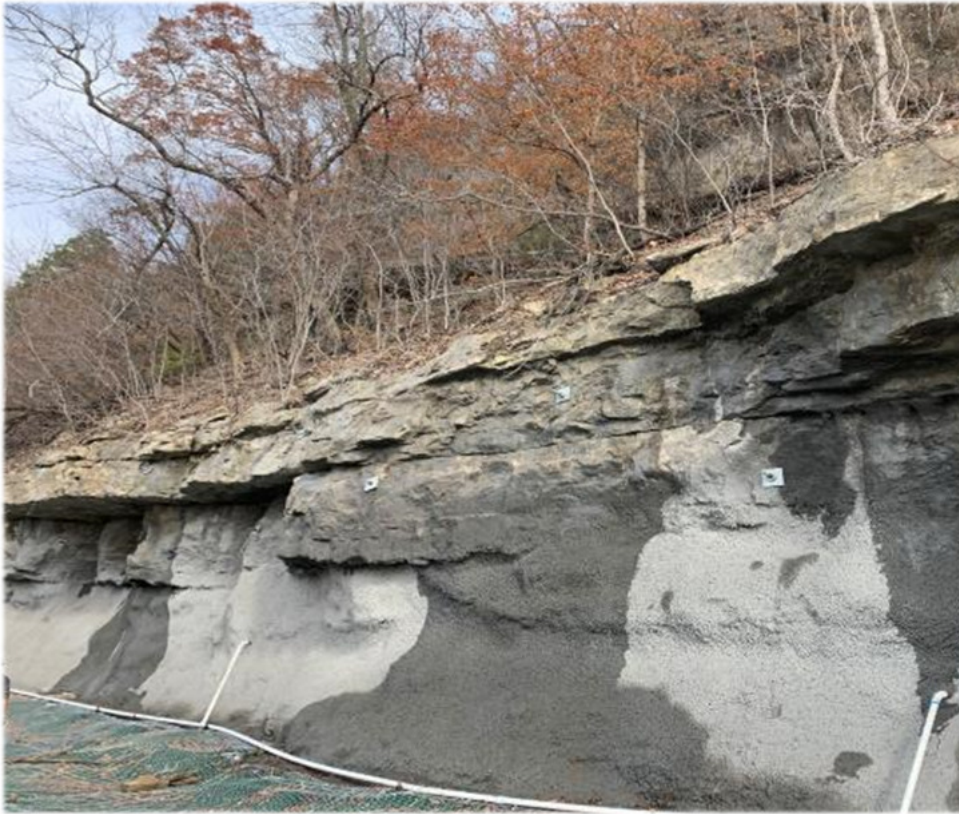
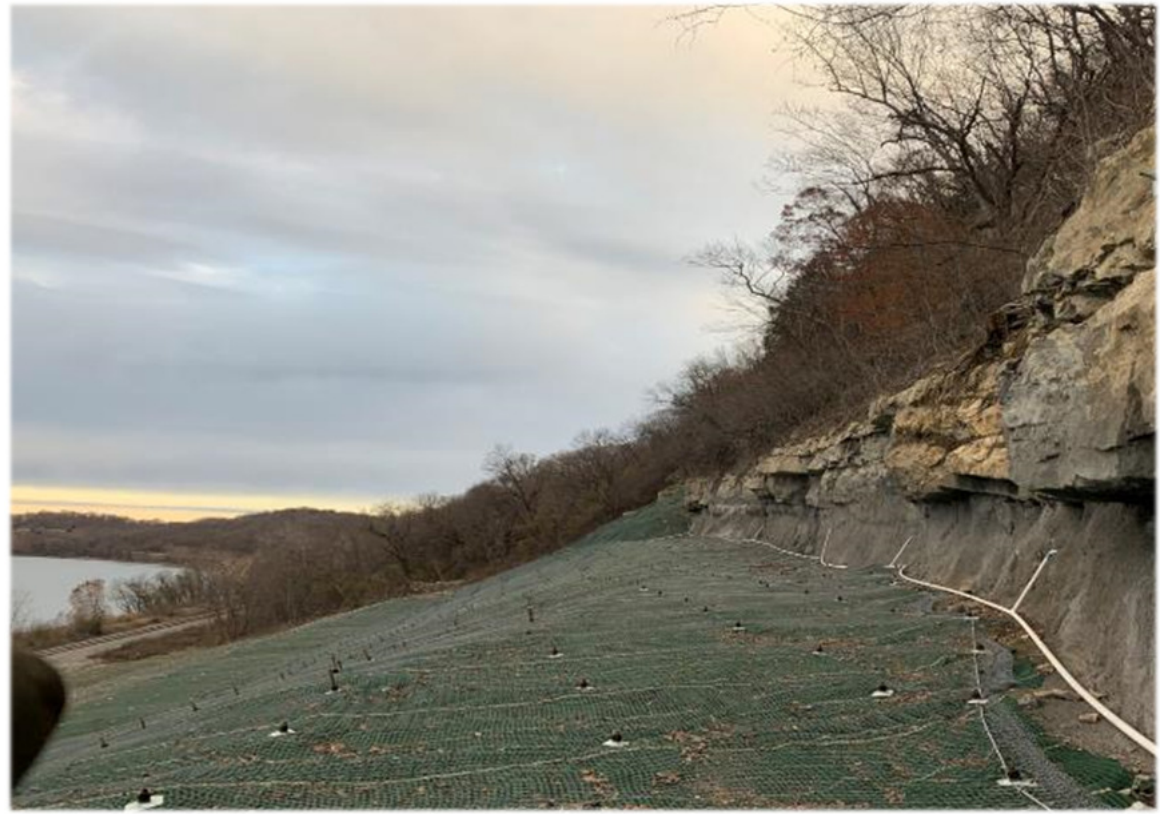
Final Pins and Drainage Installed – December
